Misalignment and balancing problems at a refinery

by **Mariano Sanchez Cabra**
Chief Engineer, Mechanical
Maintenance Department
Tula Hidalgo Refinery
Mexico

Petroleos Mexicanos' (PEMEX) Tula Refinery is located near Mexico City, Mexico, and employs approximately 4000 people. Its close proximity to Mexico City, and the large amount of petroleum it processes (315,000 barrels/day), make it one of the most important refineries in Mexico. This facility supplies Mexico City with gasoline, aviation fuel, liquid gas, paraffin, diesel and butane.

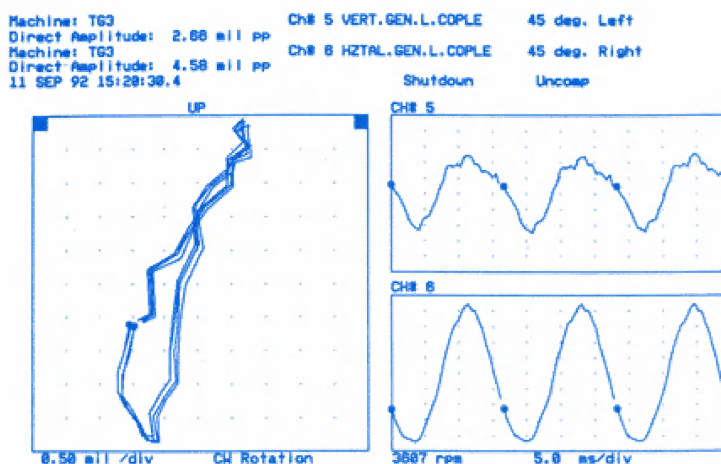
analysis of the recorded data showed that Bearings No. 1, 2, 3 and 5 were heavily preloaded. Bearings No. 2 and 3 showed a figure-eight shaped Orbit, as is shown in Figure 2.

Figure 2
Startup data showing figure-eight shaped Orbit

The presence of the heavily pre-loaded Orbits (indicated by the figure-eight shape), along with the high vibration levels, clearly indicated that the problem was a combination of severe misalignment and mass imbalance.

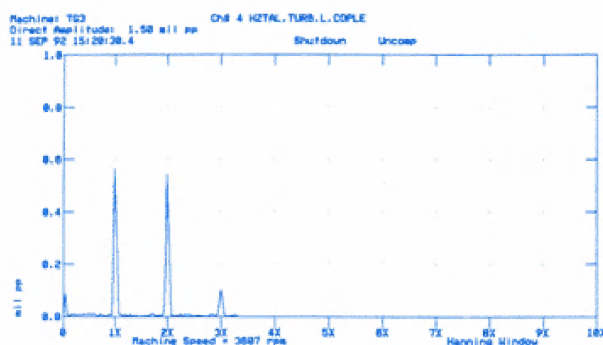
The horizontal probe of Bearing No. 2 showed a significant 2X vibration component (Figure 3). Bearing No. 2

The existence of a vibration component at twice running speed (2X), which has the same amplitude as the component at running speed (1X), might indicate misalignment.

Figure 3
Bearing No. 2 showing 2X vibration component

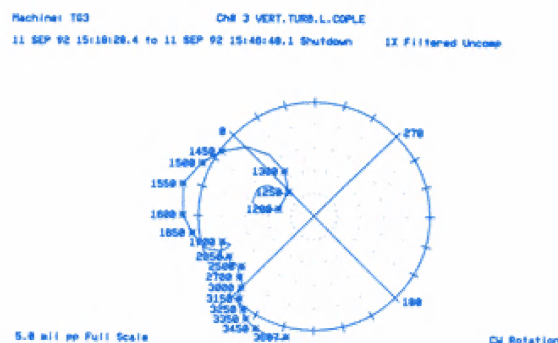
showed a vibration level of 6 mils at running speed (Figure 4). Bearing No. 4's vertical channel displayed a vibration amplitude of 8.5 mils at the first balance resonance and a residual level of 5.0 mils at running speed (Figure 5).

Figure 4
Uncompensated Polar plot of Bearing No. 2

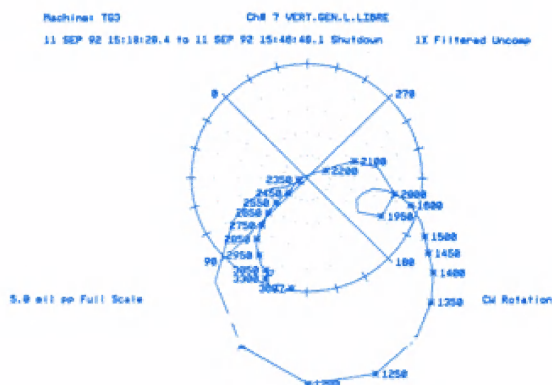
The uncompensated Polar plot (Figure 5) shows a high level of slow roll which indicates the generator's shaft is

bowed. This bowed condition is also the cause of the high vibration levels during the first balance resonance. The high vibration levels also show the rotors are operating near the pivotal mode.

Figure 5
Uncompensated Polar plot of Bearing No. 4

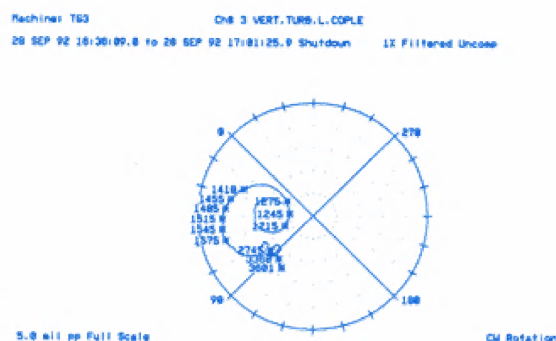
Figure 6
Uncompensated Polar plot of Bearing No. 2 after alignment

The turbogenerator was put on-line and is working reliably at full load. Vibration levels at every monitored channel decreased at critical speed and at running speed (Figures 6 & 7). Orbit/Timebase plots taken after the alignment correction are more elliptical (Figures 8 & 9), not the figure-eight

After the alignment correction, plant engineers balanced the machine train. Vibration levels were recorded on all
